IMPROVED SAFETY FEATURES FOR MULTI-LANE ROUNDABOUTS

Abstract

This paper is a brief summary of some findings from a two-year research project recently completed for the New Zealand Transport Agency (NZTA), three topics of interest being:

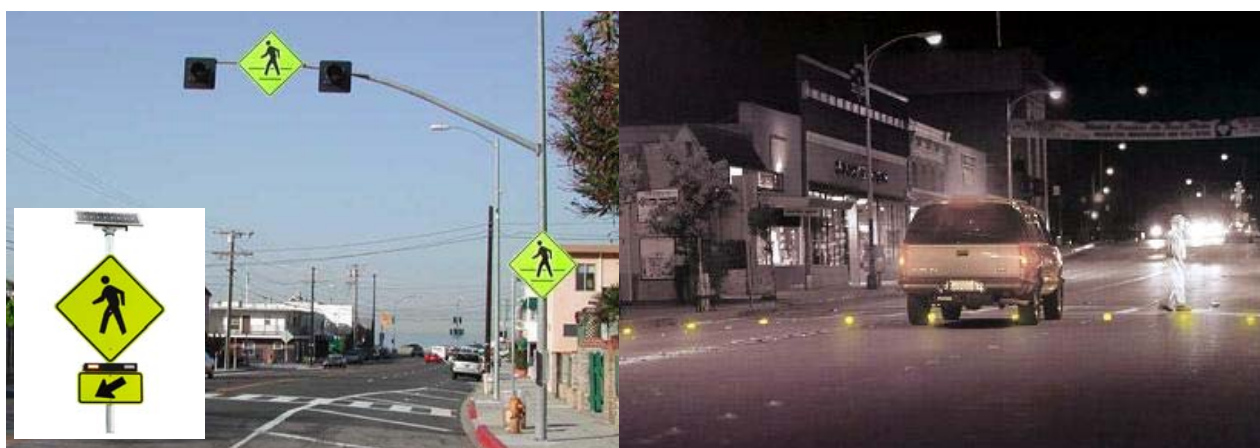
FIGURE 1: Flashing road sign (left) and road stud (right) installations in the US, with the more recently developed RRFB shown inset left.

Improvements to zebra crossings that have demonstrable benefits are activated flashing road studs or signs as shown in Figure 1 (Parevedouros 2001, Van Derlofske et al 2002, Hakkert et al 2002,

Huang et al 1999), and the road studs in particular have already been successfully trialled in New Zealand cities Auckland and Christchurch (Smith et al 2008). A 2001 study from California (Malek 2001) compared effectiveness of flashing road studs and overhead yellow flashing lights, both using identical infra-red systems for motion detection of pedestrians. The pavement lights were found to be substantially more effective in alerting drivers to the presence of pedestrians. However a recent development from the USA called the Rectangular Rapid Flashing Beacon or RRFB has also demonstrated improved performance and could be considered as a viable alternative to flashing road studs. Raised speed platforms are also an option that could also be considered for multi-lane zebra crossings, and these are further discussed in Section 3 of this paper.

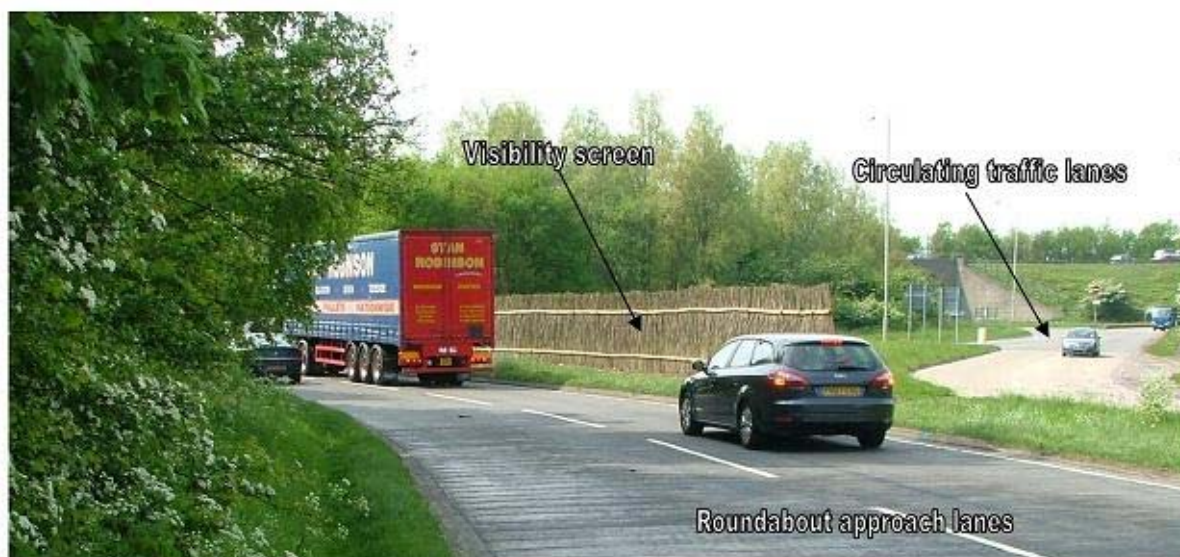
FIGURE 4: Photo taken in 2008 of a 2.5m (8 ft) high visibility screen installed on the approach to a roundabout at the intersection of the A50/A511 and Junction 22 of the M1 motorway in Markfield, Leicestershire County Council, UK.

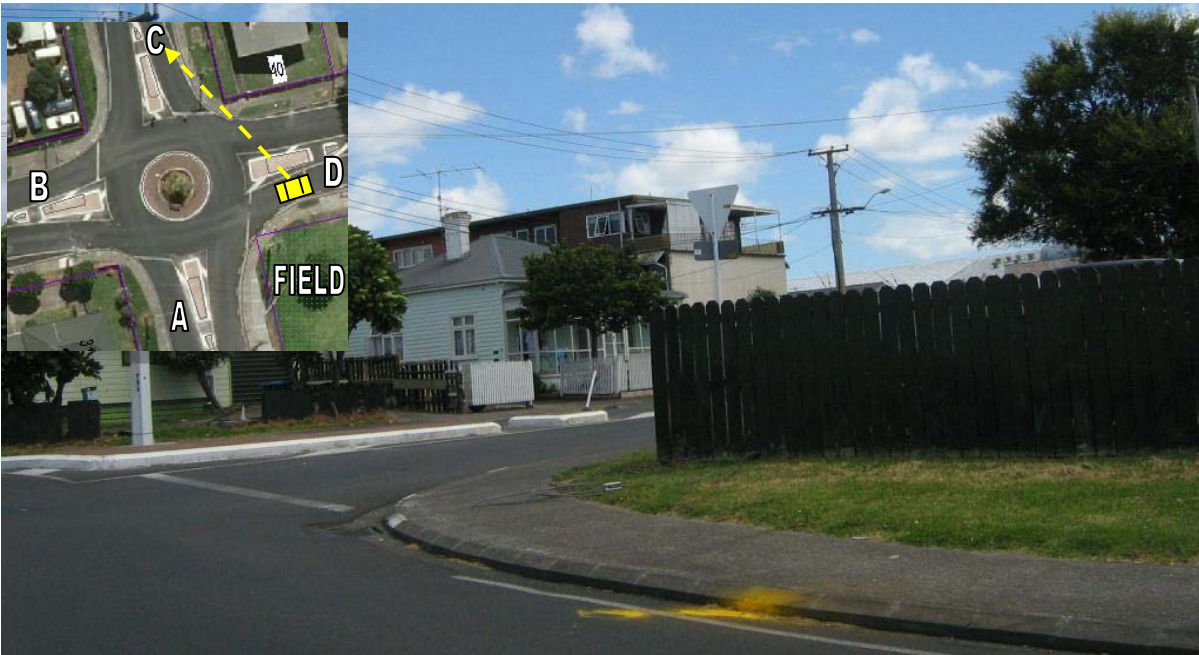
FIGURE 5: Example photo taken 10 m (33 ft) back from the limit line on approach D to the small Church Street / Avenue Road roundabout in Otahuhu, Auckland. Sightline restrictions are almost identical for approaches B-D, whilst approach A has virtually unimpeded visibility due to the presence of a field on the right.

- It has an unusual combination of sightline constraints (refer Figure 5), with three of the four approaches being restricted by corner boundary fences (shown as approaches B – D), and the fourth having almost unimpeded visibility across a sports field (shown as approach A).
- It has previously been identified as a site with an unusual crash pattern (refer Figure 6) which appeared to be related to these sightline constraints. All the reported crashes involved straight-through versus straight-through vehicles, and 13 of these 16 crashes (or 81%) involved vehicles from approach A. Higher vehicle speeds through the roundabout from the Church Street southern approach A appeared to be a major factor in the crash pattern here. Traffic volumes are reasonably comparable for each of the four approaches, and certainly not reflective of this crash pattern.
