Pedestrian Crosswalk Signals at Roundabouts: Where are they Applicable?

Bill Baranowski, P.E. RoundaboutsUSA

Pedestrian Crosswalk Signals at Roundabouts: TRB Roundabout Conference May 2005

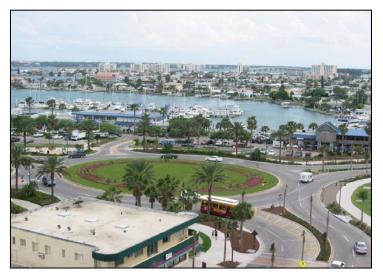
CLEARWATER BEACH, FLORIDA

The Clearwater Beach roundabout has been in operation for at least three years and is famous for the high amount of vehicle and pedestrian traffic during spring break periods. (58,000 vehicles per day and up to 6,000 pedestrian crossings per day) The original design included a signalized pedestrian crosswalk shown on the leg at the upper right by Crabby Bill's Restaurant. The crosswalk on the leg on the lower right was relocated farther from the circle and operates well without a pedestrian crosswalk signal.

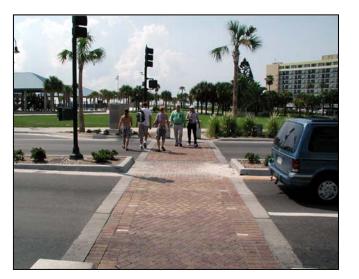
The pedestrian crosswalk signal shown at right (looking away from Crabby Bill's Restaurant) was found to cause congestion inside the roundabout and was removed. Pedestrians at times are so numerous that they tend to dominate the vehicle traffic on this leg of the roundabout.

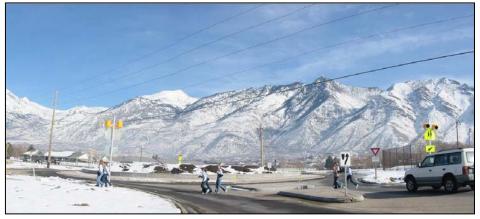
ALPINE CITY, UTAH

The Alpine City Main Street roundabout is located near an elementary and a middle school. Children use the new roundabout as part of their safe route to school route. During school crossing times there is a crossing guard helping students across the

intersection. When the crossing guard is present the Yellow lights shown are in constant flashing operation. During off-peak times pedestrians may push a button which activates the crosswalks flashers for a long enough period of time to allow the pedestrians to cross the street safely at the roundabout. This signal does not meet MUTCD warrants but is considered an experimental application.

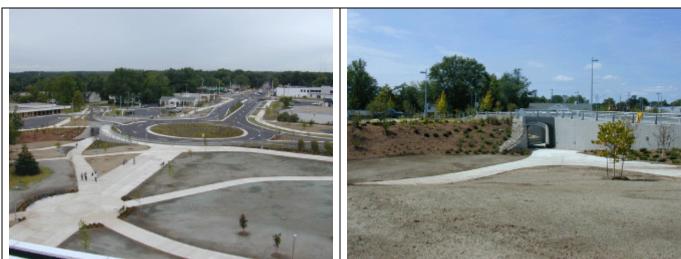
WMU Rbt Pedestrian Underpass to Left

The Department of Blindness and Low Vision Studies at Western Michigan University offers graduate students preparation for becoming orientation and mobility specialists, rehabilitation teachers, teachers of visually impaired children, and rehabilitation counselors. A roundabout was constructed in Summer 2004 at the western entry into campus that includes a pedestrian underpass that routes pedestrians under the roundabout. Unfortunately, not every City or development has the funds to provide this separation between vehicles and pedestrians.

WMU Pedestrian Underpass (The CSM Group)
