How We Fixed a Roundabout to Match Driver Expectations

SH-82 & Maroon Creek Rd, Aspen

Colorado Dept of Transportation - Region 3 Traffic Section

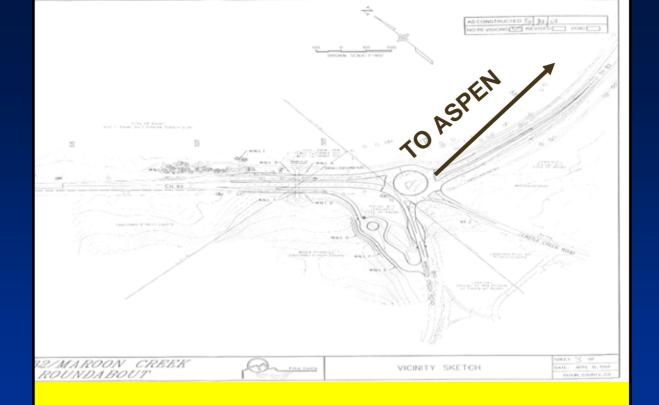
Original Roundabout Design

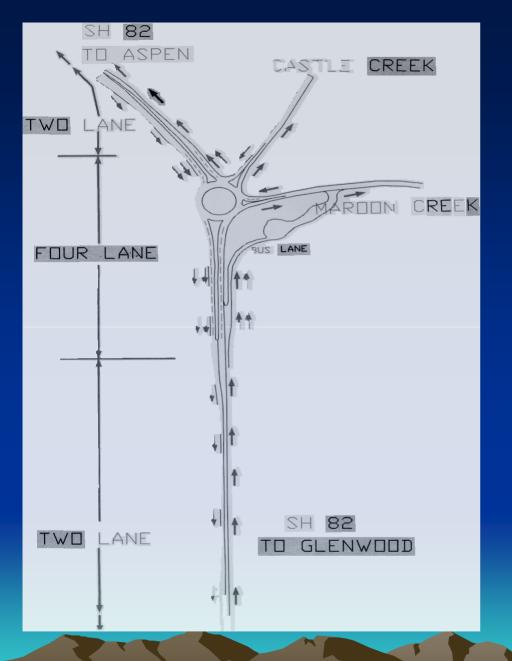
Problem Illustration

Morning peak hour traffic backs into roundabout from two-lane Aspen direction

Roundabout "fills up" as cars attempt to use right lane for thru traffic to Aspen

Roundabout no longer has right turn capability for Maroon and Castle Creek exits

Circulating traffic is blocked

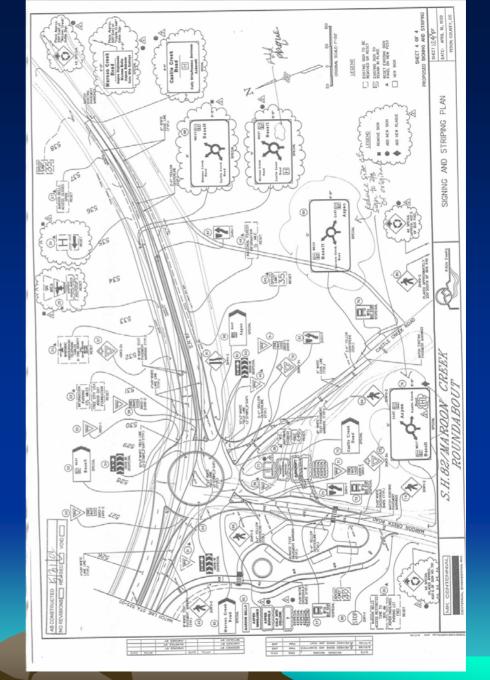
Original Sign Plan

Signs are crowded & need consolidation

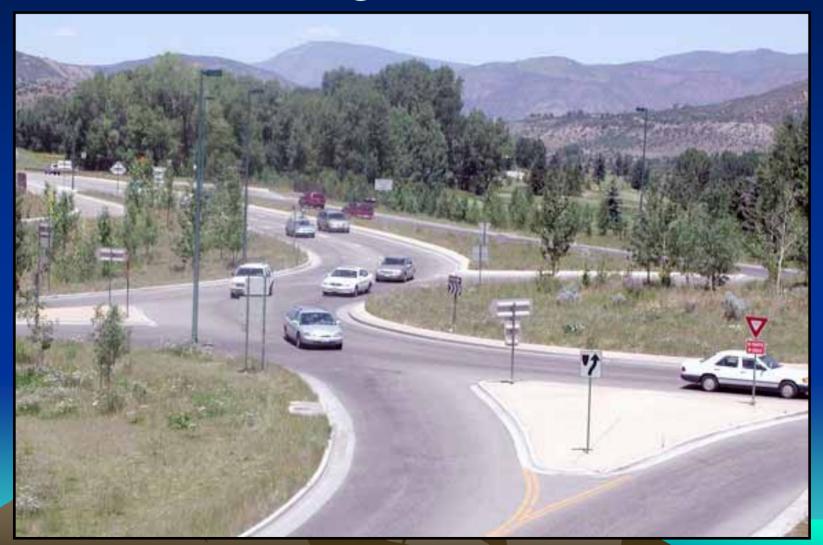
Aspen-bound traffic entering Roundabout

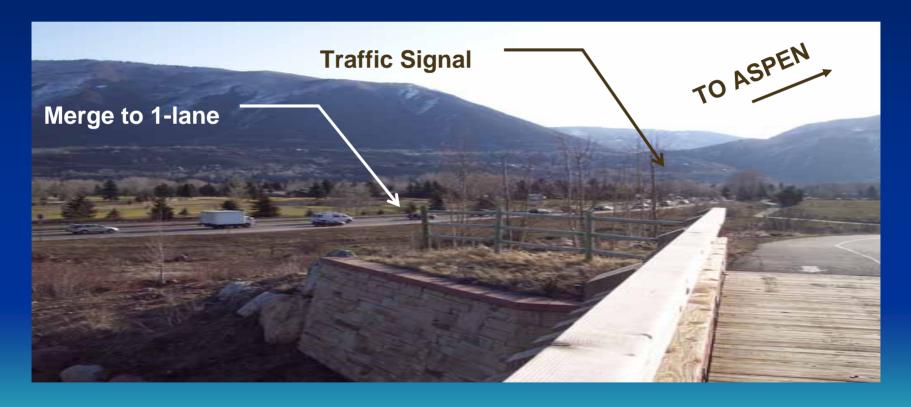
Source of Spillback

Aspen-bound Traffic Restrictions

- Total Upvalley traffic flow is limited by the one lane capacity between the roundabout and Aspen
- This merge point is located just 300 feet Upvalley from the roundabout and there is a traffic signal a few hundred feet past the merge point
- Peak hour volumes exceeded the available one lane capacity and caused queuing and spillback through the roundabout and a substantial distance upstream of the roundabout

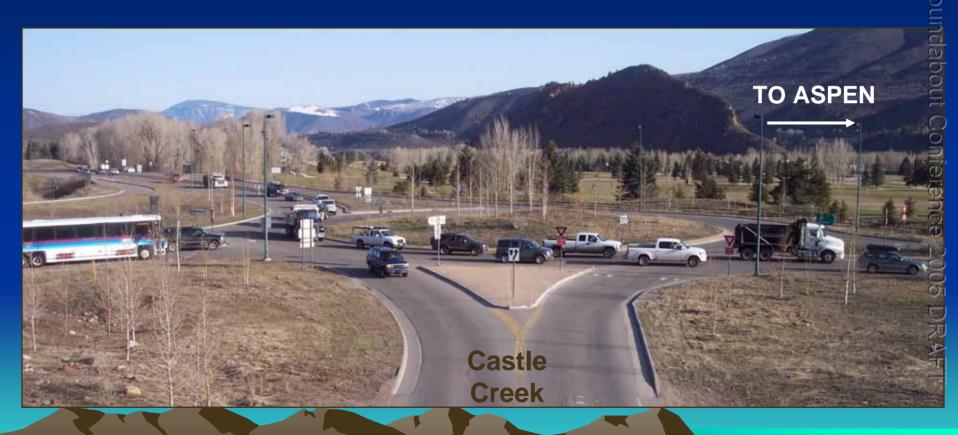
Spillback Impact to Roundabout

Morning Peak gridlock

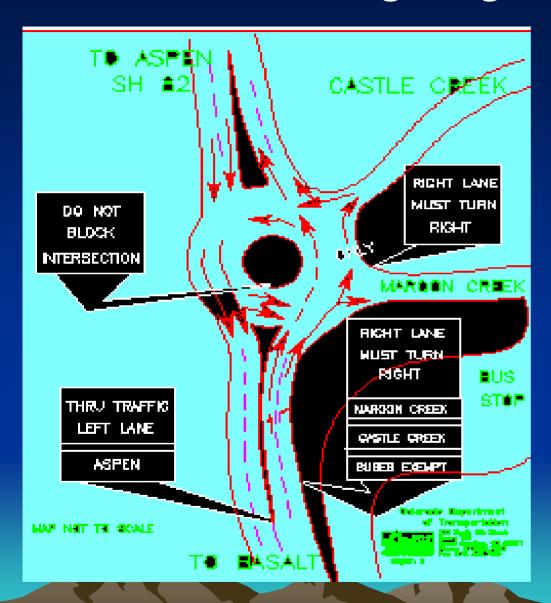
Signing Plan

Install 4 new signs

Right Arrow pavement marking at Castle Creek

Straight-Right Arrow at Maroon Creek

- Sign Aspen-bound traffic to stay in Left Lane Only.
- Sign & place pavement markings for Maroon Creek and Castle Creek turning traffic to "Right Lane Only".
- Sign to discourage Aspen-bound traffic from blocking the roundabout.
- Use radio and news to inform public.
- Maintain Bus traffic in right lane.

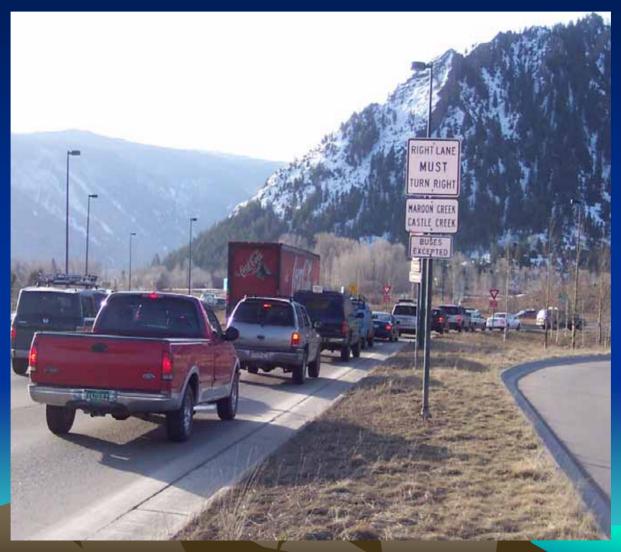
Right Lane Must Turn Right to Maroon and Castle Creeks

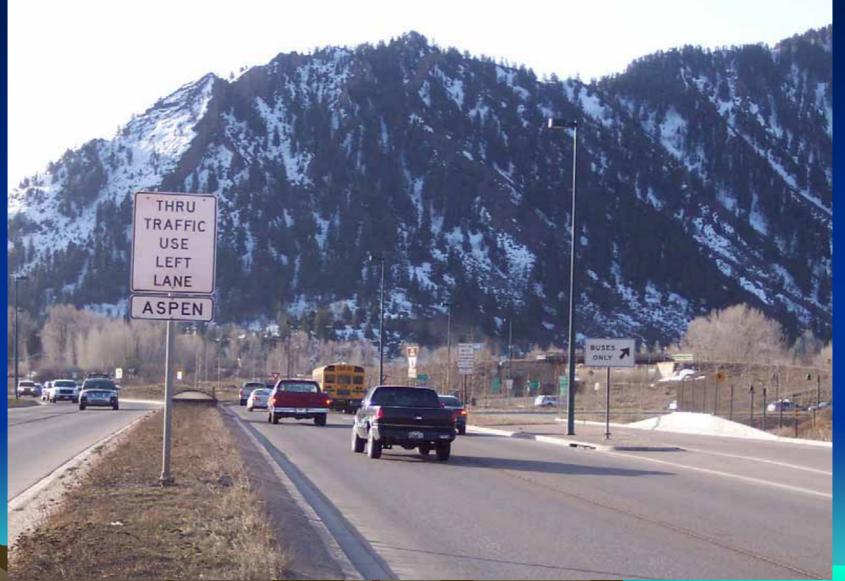
Thru Traffic Use Left Lane - Aspen
