# **An Examination and Recommendation for Current Practices in Roundabout Lighting**

**July 31, 2004**

Paul Lutkevich, Parsons Brinckerhoff Quade & Douglas, Inc  
Professional Associate  
75 Arlington St.  
Boston, MA 02116  
(T) 617-960-4903  
(F) 617-482-8487  
Lutkevich@pbworld.com

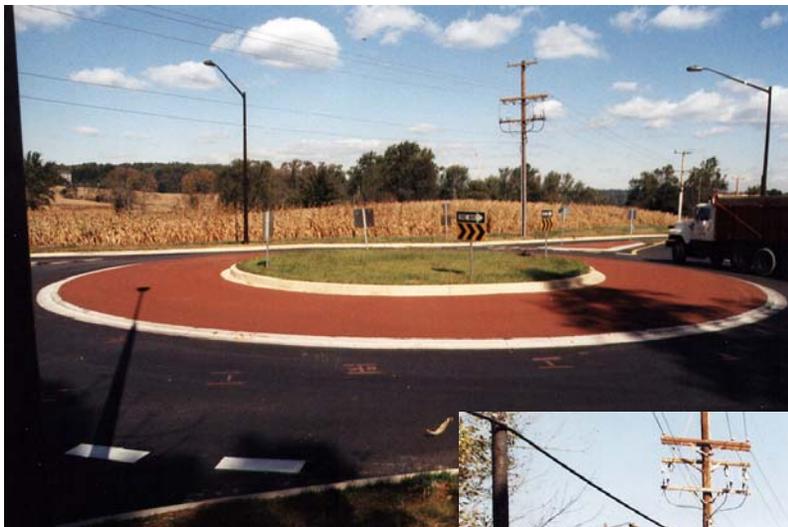
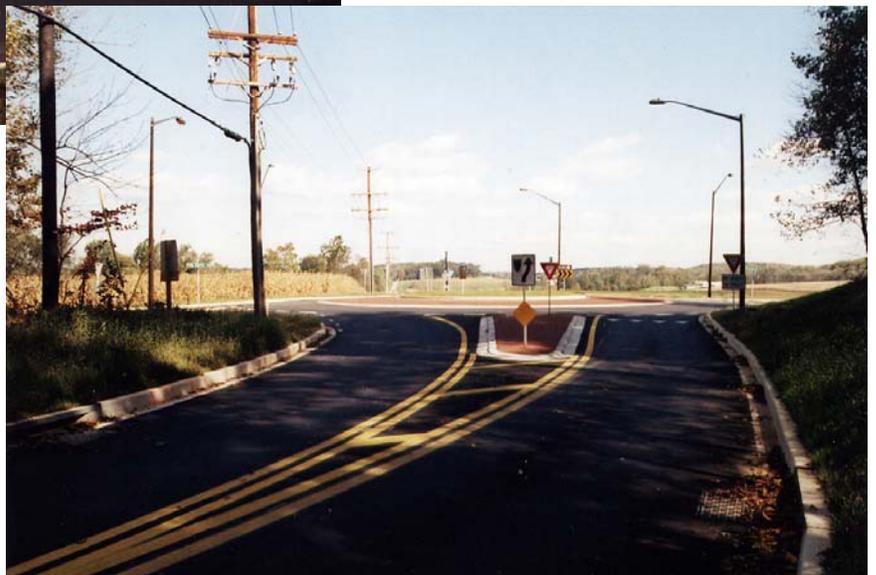
- Intersection of Shepherd and Folly Quarter Roads in Howard County, Maryland. This roundabout was chosen because it is a rural single lane roundabout that was newly constructed. On visiting the roundabout it was found that the lighting had not been activated and the site proved useful for gathering information on roundabouts in an unlit condition.

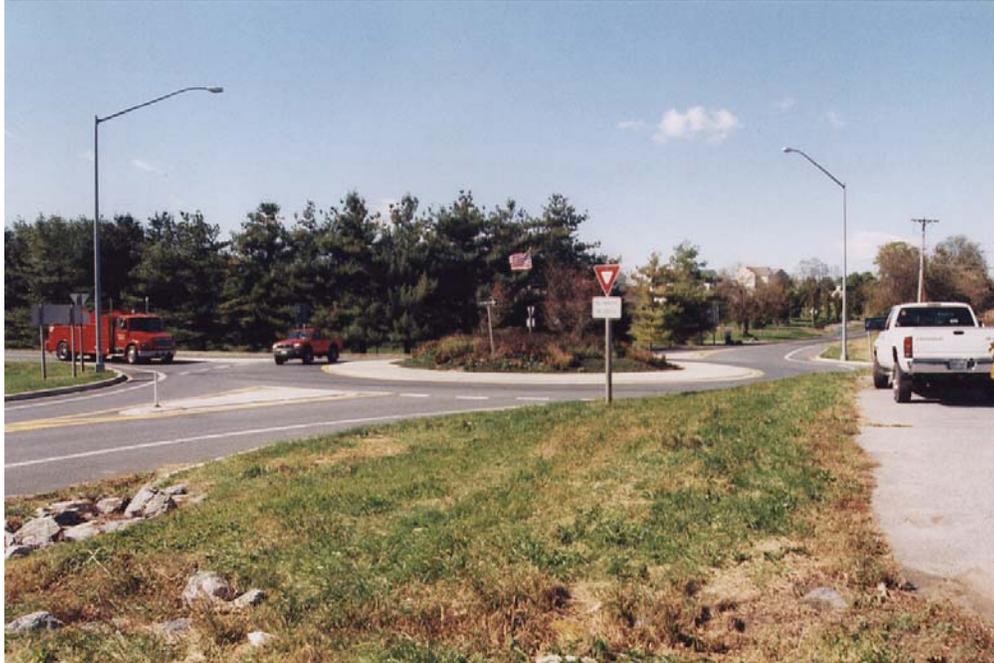
- Intersection of Woodbine Road and Route 40 in Lisbon, Maryland. This rural single lane roundabout is in close proximity to Interstate 70. It was chosen because it has only two light fixtures located diagonally across from each other as shown in the Figure 1. It provides a good example of a roundabout with minimal lighting.

This roundabout in Lisbon, MD is lit with two 250 watt high pressure sodium cobra head fixtures and illustrates a step up from no lighting to what could be considered “minimal lighting”. The lighting levels at this location averaged between 8 lux and 12 lux. This level of lighting does overcome the worst aspects of no lighting – i.e. providing some preview distance to the driver circulating in the roundabout. Other observations include:

- Lack of uniformity in the lighting does not provide a comfortable or reliable driving environment.
- In locations where crosswalks would be available, this lighting does not provide adequate lighting to make the pedestrian visible in at least half of the crosswalks. As such, driver and pedestrian expectancies are not matched in all situations.
- Considering typical maintenance cycles, if one light goes out, the negative effects are far greater than they would be with other, more extensive lighting configurations.

Taking the above into consideration, this lighting arrangement is not practical for most applications. However, in a rural environment with no pedestrians and where funding for installation and maintenance of lighting equipment is limited, this would be a useful approach. However, higher levels of lighting would be far better if at all possible and should be installed whenever possible.

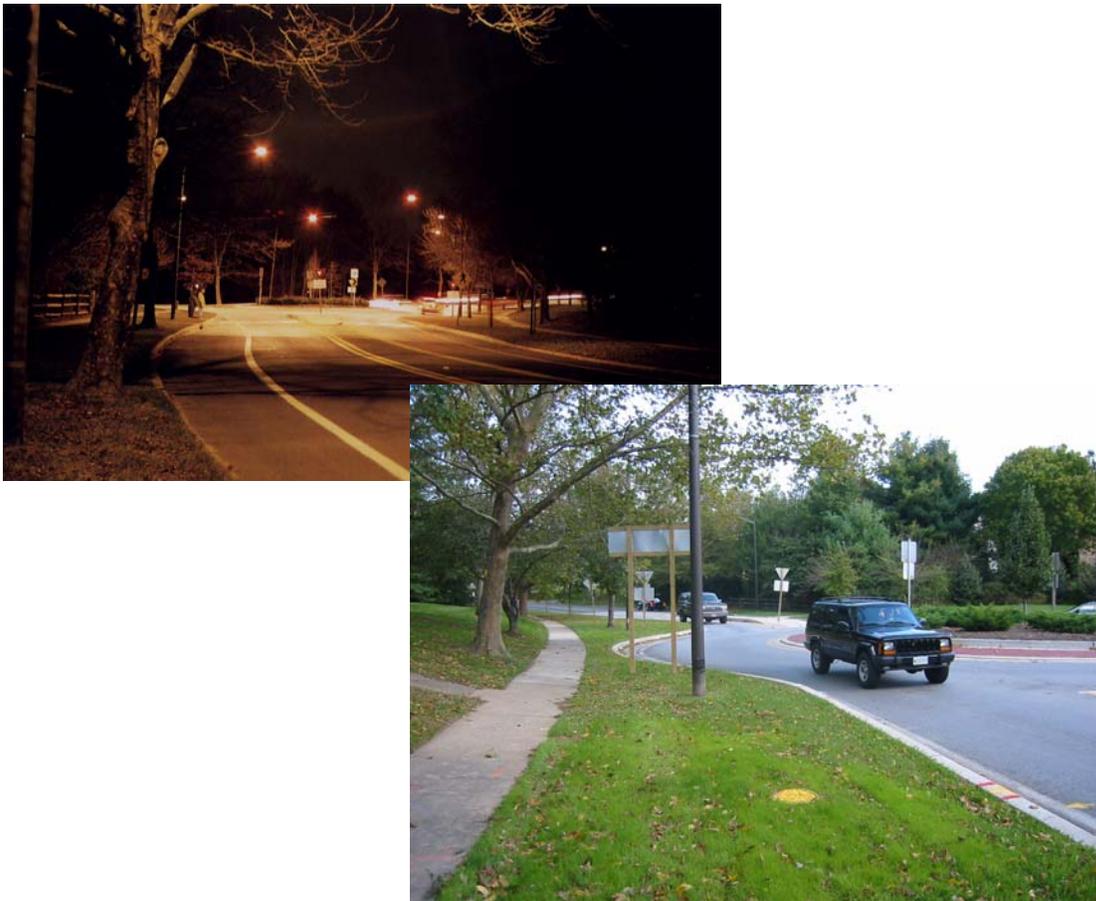
- Intersection of Cradlerock Way and Homespun Drive in Howard County, Maryland. This single lane, 3-leg, suburban roundabout was chosen because it has light fixtures placed in close approximation to the French Roundabout Lighting Guide as shown in Figure 3. It provides a good illustration of lighting the roundabout approaches, crosswalks and circulatory roadway.

This suburban roundabout has three approaches with pedestrian crosswalks on all legs. Lighting is symmetric around the circular roadway and includes approach lighting in advance of all crosswalks. Four 250 watt high pressure sodium cobra head luminaries are placed around the roundabout with one unit on each of the approach roads. Lighting levels averaged 30 lux to 40 lux in the roundabout and vertical illuminances at the crosswalks ranged from 20 lux to 40 lux. Observations from analysis of this roundabout include:

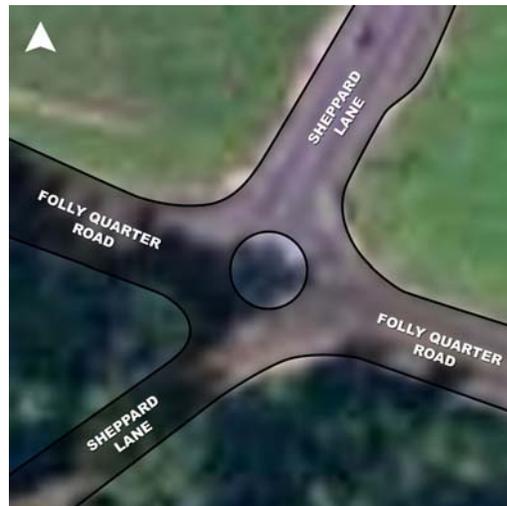
- When negotiating a roundabout at night, the driver's eyes are directed to the left through the driver door window. However, the headlights of the vehicle are directed tangentially off of the roundabout and therefore provide no visual support to the driver. As a result, the driver has little or no visual cues either upon entering or circulating in the roundabout. The experience indicates the importance and necessity of lighting of roundabouts, especially in the absence of any other light sources.

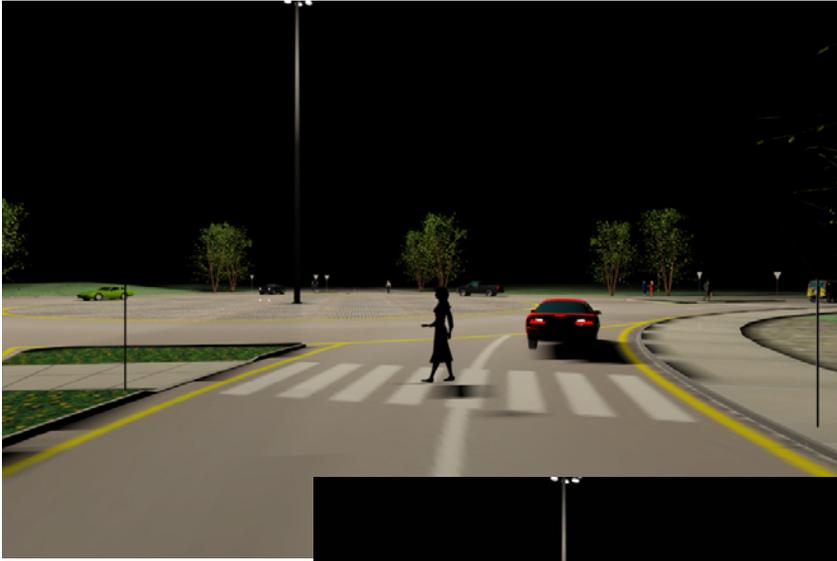
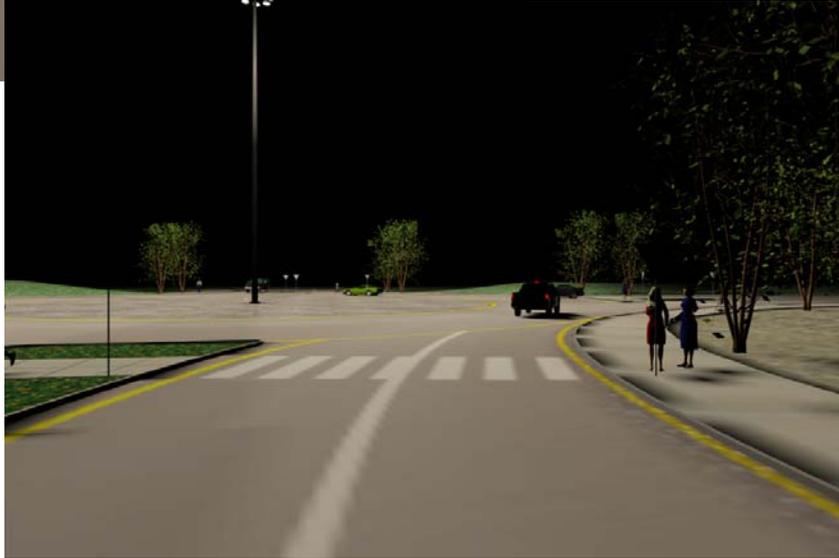
To simplify some of the visibility complexities we also prepared computer models to compare roundabout only lighting and a roundabout that also had approach lighting. For the roundabout only system we used a 24 meter pole with 8-400 watt high pressure sodium luminaires.

The images generated by the computer models as well as the calculated values of all of the surfaces seemed to show preferable pedestrian visibility with an approach lighting system.

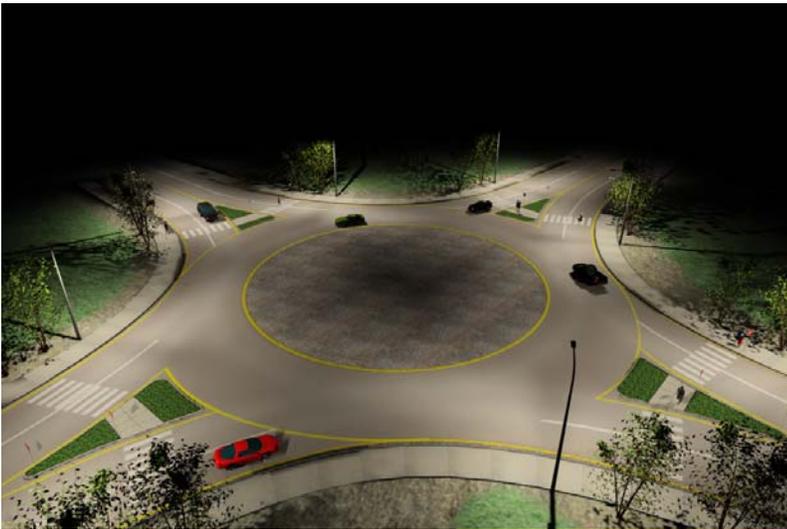
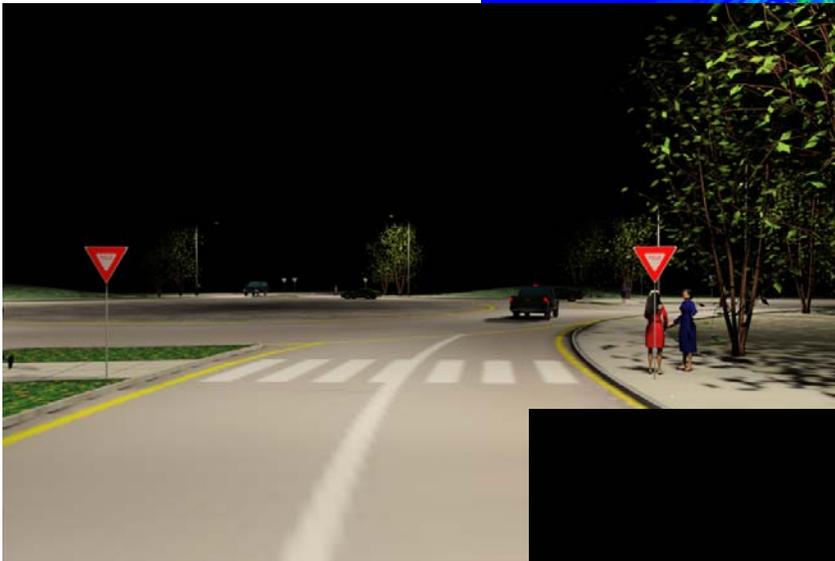
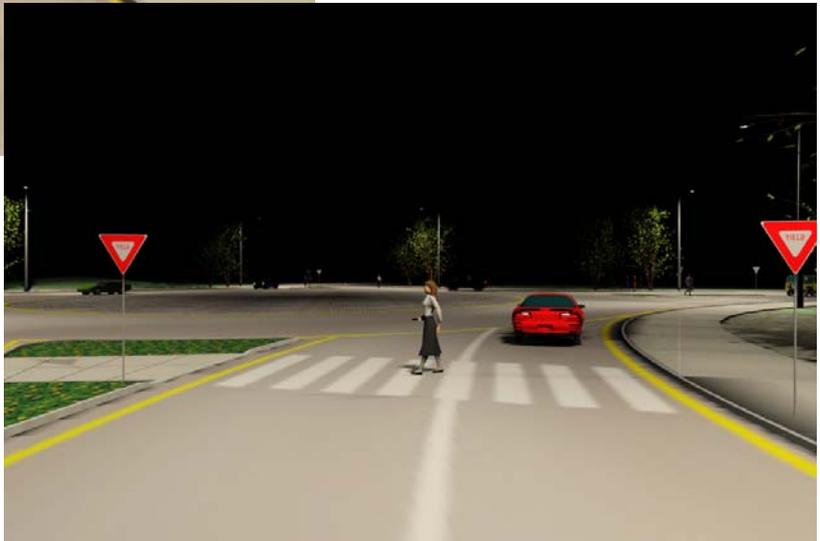
For the roundabout with approach lighting we used 8-10 meter poles with 250 watt high pressure sodium full cutoff cobra head luminaries.
